Manhole Inspection Summary

Manhole # S25C1_008MH

Location Address: **2344 ANNAPOLIS RD.**

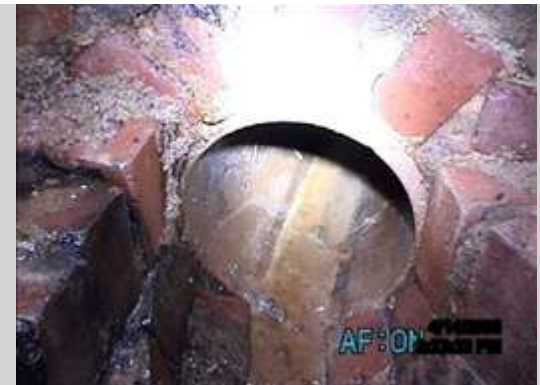
9 O'Clock Inflow

Pipe Height: **8.4** (in.) Rod and Bar (Angled)
Pipe Material: **Clay** ☐ Pipe Lined
Invert Depth: **5.90** (ft.) Flow Characteristics: **None**
Deposits: ☒ **None** ☐ Mud ☐ Sludge ☐ Debris ☐ Grease
Silt Depth: **0** (in.) Deposits Extent:
Infiltration: **None** Pipe Seal Cond: **Unknown**
